**Re: Ameren Missouri
Labadie Power Station
Response to O'Brien & Gere Draft Dam Safety Assessment of
CCW Impoundments**

This report presents our findings and recommendations from the geotechnical field investigations, laboratory testing, land survey, and slope stability analyses of the dams impounding the ash ponds at the Labadie Power Station. The investigation, testing and analyses was done in general accordance with our proposal dated January 29, 2010, and Ameren Missouri's request for proposal dated December 9, 2009. The purpose of this project is to evaluate the stability of the ash pond dams and conduct the necessary land surveys, subsurface explorations, and laboratory testing to define the critical section at each location. The slope stability analysis conducted was for the load cases required by the Missouri Department of Natural Resources (MDNR). The results of the slope stability analysis were compared to the required safety factors for the type and assumed hazard classification of each dam.

Ash Pond Stability
Labadie Power Plant
CLIENT: **Ameren Missouri**

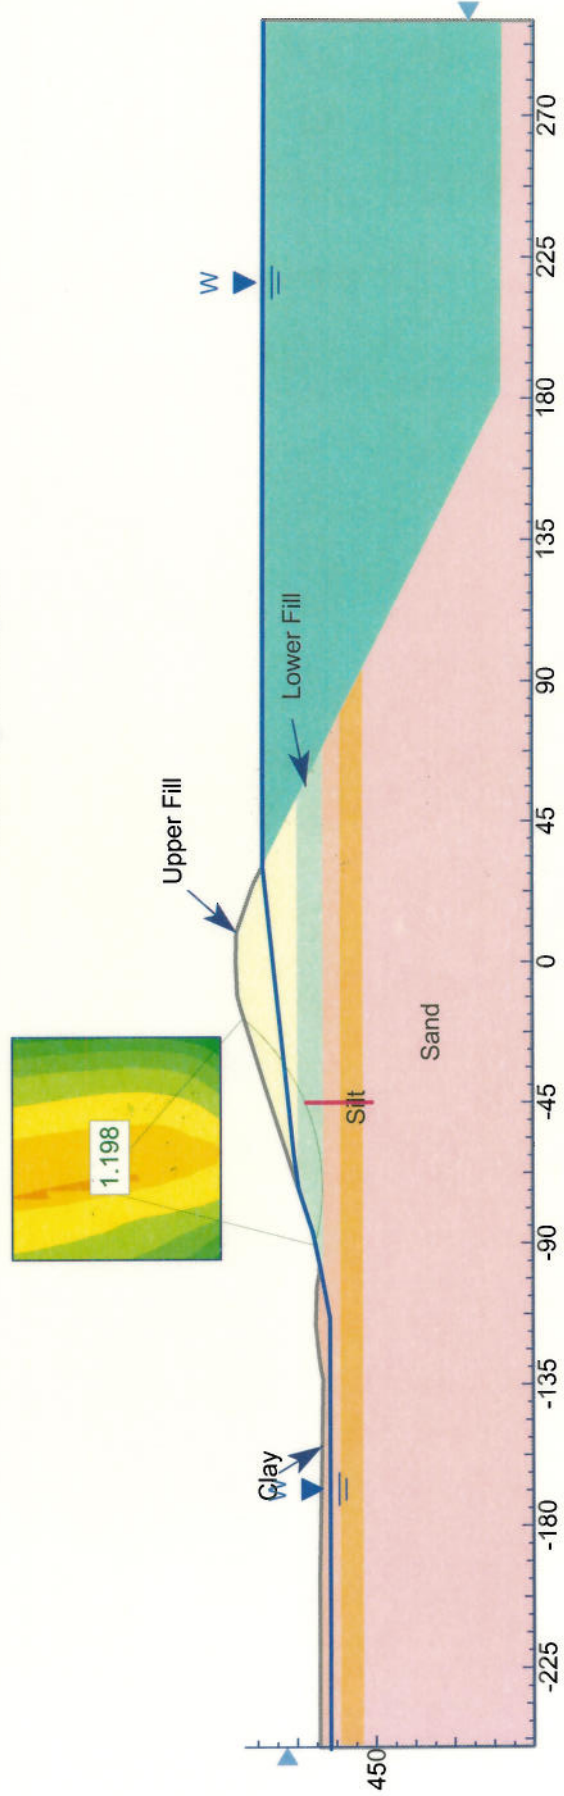
Material: Sand
Unit Weight: 120 lb/ft³
Friction Angle: 32 degrees

Material: Bottom Ash
Strength Type: No strength
Unit Weight: 100 lb/ft³

Cross-section 5 was also analyzed for the steady seepage load case at normal pool only. This section was surveyed near the location of PZ-2 and the area where seepage has been observed in the past. The analysis limited the search for a critical failure surface to include "deep" failure surfaces only or slope failures that would require significant effort to repair. The factor of safety for "deep" failure surfaces was approximately 1.7.
